Manhole Inspection Summary

Manhole # S29SS_016MH

Insp Date: **5/15/07 9:05 AM**

Location Address: **2801 SISSON ST**

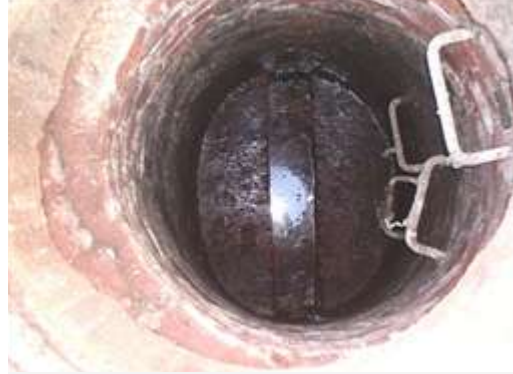
Top View

Corroded steps. Evidence of surcharge - Bench debris. Channel debris.

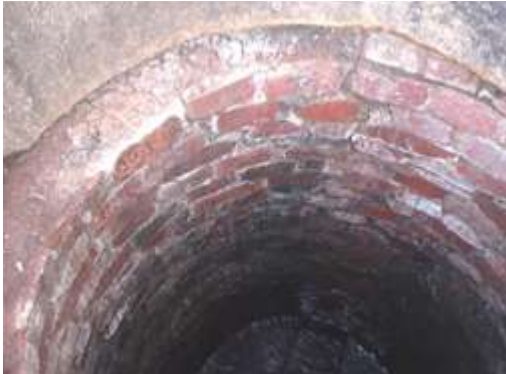
Defect

Frame leaks. Frame offset. Adjustment deterioration and infiltration. Barrel infiltration - other side.

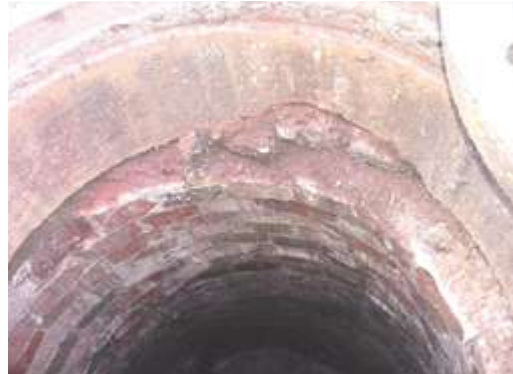
Defect

Frame leaks. Frame offset. Adjustment deterioration and infiltration.

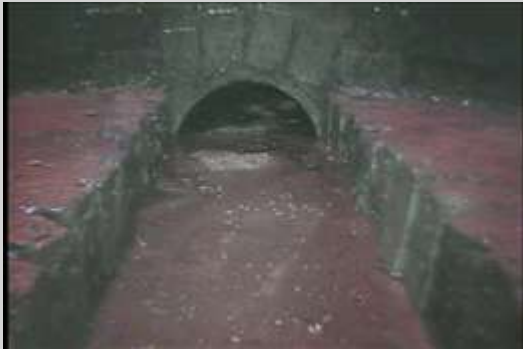
8 in. Circular Gravity Sewer Pipe Out @ 12 O'Clock

Deposits: ☐ None ☒ **Mud** ☐ Sludge ☒ **Debris** ☐ Grease

Silt Depth: **3** (in.) Deposits Extent: **Medium**

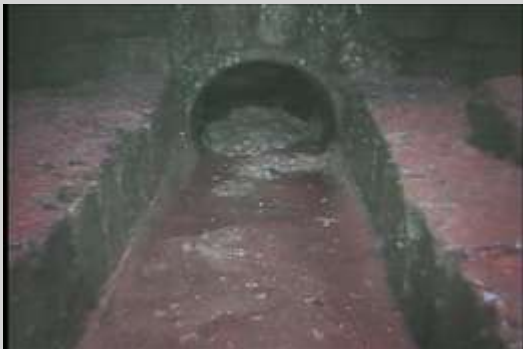
8 in. Circular Gravity Sewer Pipe In @ 6 O'Clock

Deposits: ☐ None ☒ **Mud** ☐ Sludge ☒ **Debris** ☐ Grease

Silt Depth: **2** (in.) Deposits Extent: **Medium**
